Saving Money by Extending the life of New Zealand Heritage Bridges

Raed El Sarraf WSP Opus, Natalia Uran WSP Opus, and Liam Coleman NZTA

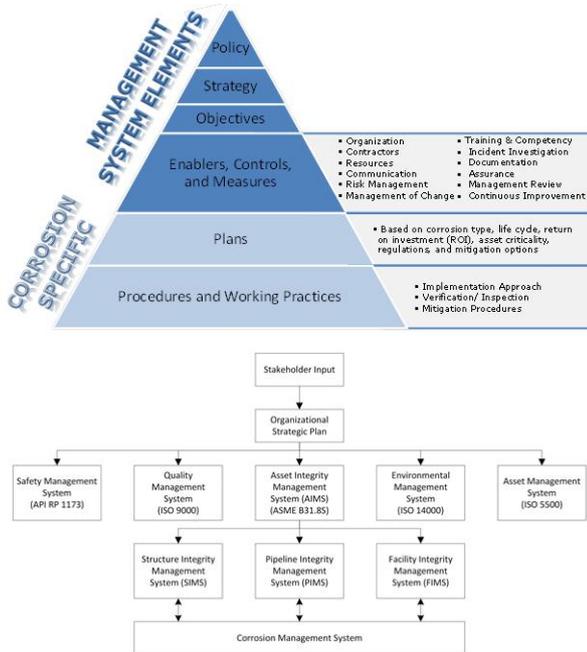
Figure 1 outlines where Corrosion Management sits within the Asset Management field. The data generated is then used to develop asset management plans, strategy and policy. Whilst Figure 1 is given in relation to the Oil and Gas Industry, the principles are easily adapted to bridges and the roading network.

Figure 1: Corrosion Management in the Asset Management (images courtesy of NACE).

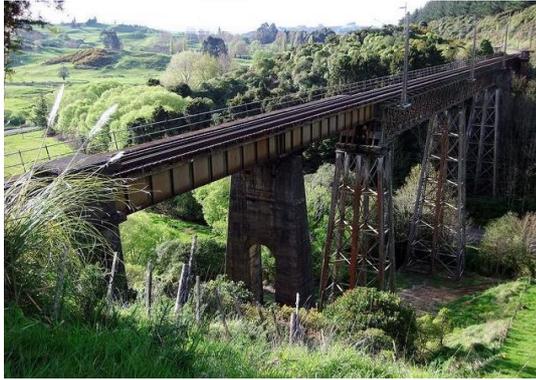
KiwiRail's historic Waiteti Viaduct is a 128.6m multi-span, railway viaduct that has carried heavy rail traffic across the Waiteti Gorge (South East of Te Kuiti) since 1888. Throughout that time, and as the traffic became heavier and more frequent, the bridge underwent strengthening in the 1920's, 1950's and 1970's. The latest repair work was undertaken in 1983, which included the re-application of red lead primer as the main form of corrosion protection. Figure 2 provides an overview of the viaduct.

Figure 2: Waiteti Viaduct.

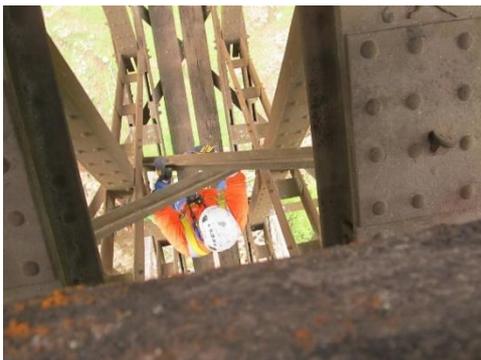
A Detailed Condition and Structural Assessment was undertaken by the authors, which included a detailed inspection and assessment of the corrosion protection system itself. This included assessing the coating according to AS 4361 and AS/NZS 2312. Including measuring the total dry film thickness of the coating, assessing the adhesion of the coating to AS 3894.9 and steel corrosion to AS 1580.481.3. The inspection was undertaken by a NACE Coatings inspector – Level 2 Certified, with a rope access training (Figure 3).

Figure 3: A qualified coating inspector in action.

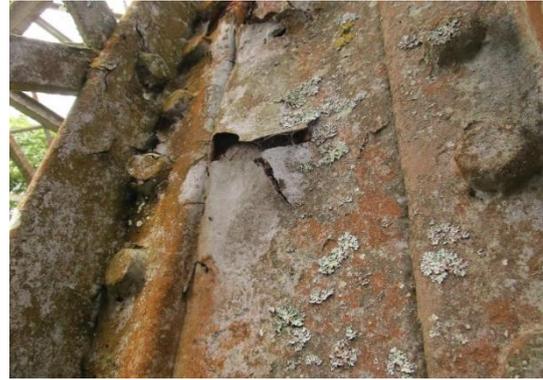
Overall the protective coating was found to be in satisfactory condition with coating delamination and/or complete breakdown estimated as up to 15-20% on some parts of the structure (see Figure 4 for an example).

Figure 4: Example of coating breakdown.

This was contrary to previous inspection records that indicated that the whole structure is covered in red rust, implying complete coating breakdown. What was previously thought to be red rust, was in fact found to be red lichen, with the coating underneath still in good condition.

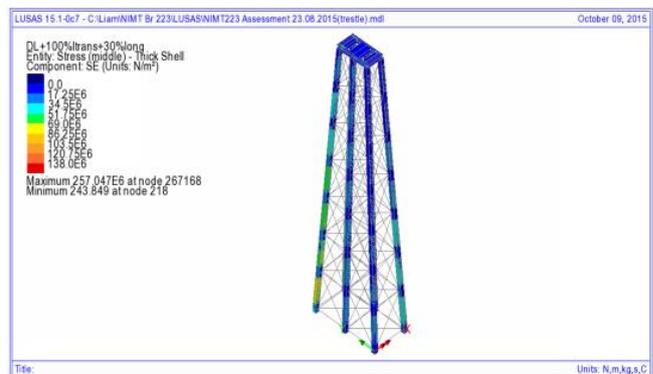
A few areas of section loss were identified and measured, as well as structural defects. This information was then used as the basis of a FEA model, that considered not only the current axle load of 18t axle load at 60 kph, but also future projected loads of 20t axle load at 60 kph and an aspirational load of 22.5t axle load at 100 kph. An example of the FEA model output is given in Figure 5.

Figure 5: Example of FEA.

Based on the findings of the Detailed Condition and Structural Assessment, it was determined that the viaduct can continue to function beyond the previously advised 2020 replacement period.

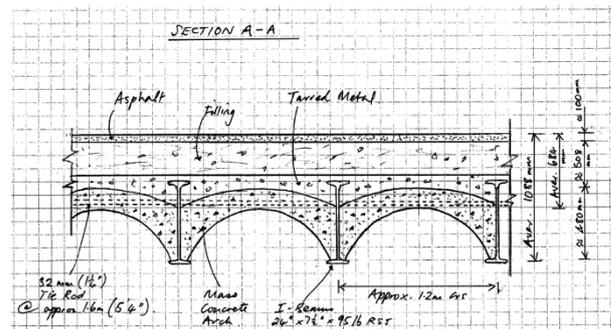
The bridges utilised a number of steel beams embedded in the concrete deck (i.e. only the bottom flange was exposed), with a hot dip galvanized corrugated iron arch used as permanent formwork. The beams had an embedded tie rod connecting them together. See Figure 6 for representative cross section of the bridge.

Figure 6: Cross section of the jack arch bridges.

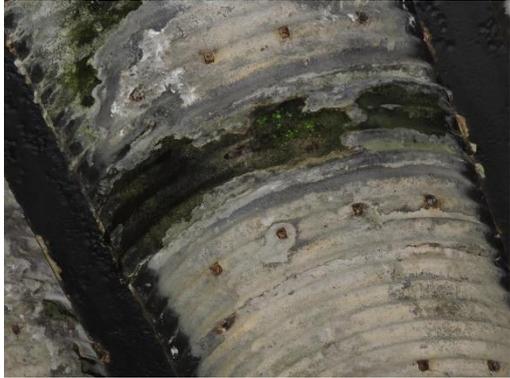
The Condition Assessment findings included measuring the remaining steel thickness of the exposed bottom flange, which still had an average thickness of 20mm (originally 25mm). With the lowest readings located beneath water leaks through the deck (Figure 7) on all 4 bridges. This was identified as being one of the critical maintenance issues on these bridges.

Figure 7: Typical example of water leaks through the deck.

Based on this corrosion rate, the potential period for the steel section to reach 12mm was estimated to be >40years. However, due to the identified water leaks and the poor condition of the steel web and beam under those leaks, the leaks were deemed to be a high risk that require urgent attention.

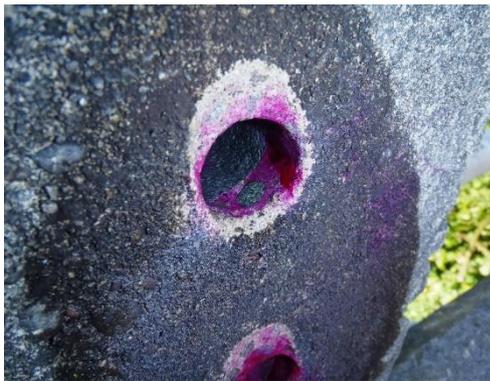
Other findings included the lack of any reinforcement to be found either in the deck or abutment. It simply was mass concrete, which probably saved the structure, as chloride ingress levels were found to be high due to the use of beach aggregate. This would have resulted in spalling of the concrete, possibly within the first 50 years of the bridge's life. Figure 8 shows concrete testing on a representative concrete component.

Figure 8: Concrete testing.

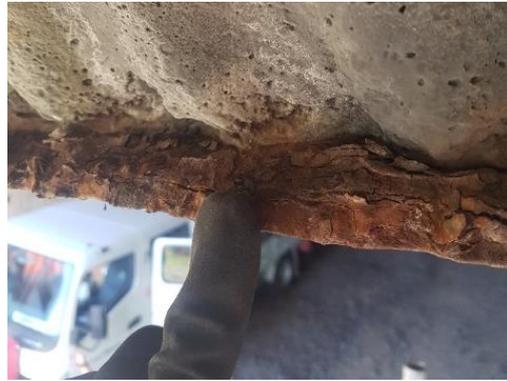
thickness of 20mm (Figure 9), the bridge was found to be at 150% capacity. It was also calculated that the critical minimum thickness of the steel flange was 12mm.

Figure 9: Typical section loss.

To determine the remaining life of the steel beams an assessment of the site atmospheric corrosivity category was undertaken. This determined the sites' micro-environments as being C5-M (Very High-Marine) to AS/NZS 2312.1. For which the steel corrosion rate was estimated as being 165µm/annum.

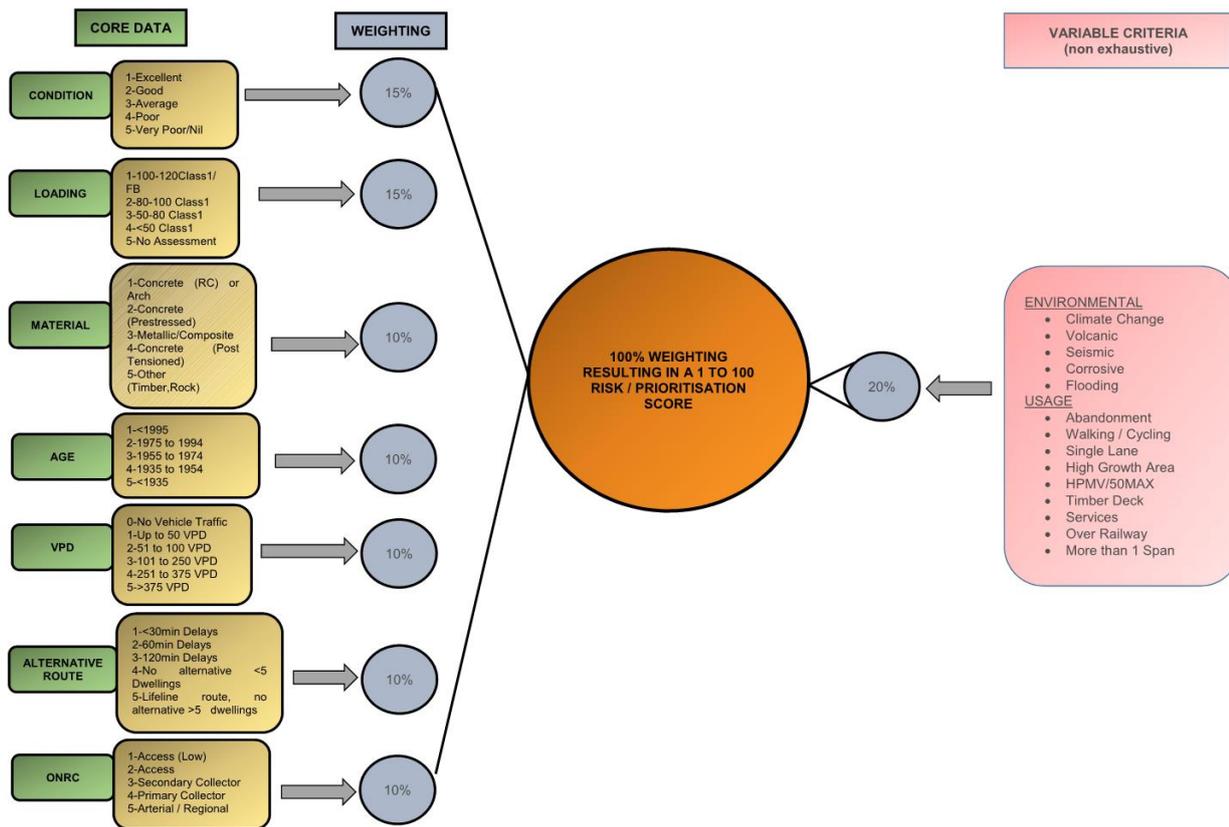
The prioritisation score system has been based on a core set of data (give in the left hand side of chart in Figure 10) which accounts for 80% of the total score and a more variable set of factors (right hand side of the chart) which accounts for the remaining 20%.

Figure 10: Risk Prioritisation Tool weighting system.

The weightings put more emphasis on the condition and loading factors at 15% each, while the rest of the factors have a weighting of 10%. These percentages are based on engineering judgement gained from extensive knowledge of bridge stock both in New Zealand and overseas, where condition and loading are considered to have a greater influence on bridge vulnerability.

- **Condition:** it grades the condition of the structure ranging from excellent (as new) with a risk score of 1, to poor condition or not inspected with a risk score of 5. This is based on bridge inspection templates, such as NZTA S6 (NZTA 2017).

- **Loading:** it considers the live load capacity of the structure in relation to Class 1 loading (general mass). The score ranges from a risk score of 1 for bridges with live load capacity greater than Class 1 to a risk score of 5 for bridges with no live load assessment information.

- **Material:** it reflects the different durability of the bridge materials. The score ranges from a risk score of 1 for reinforced concrete to a risk score of 5 for timber bridges.

- **Age:** it considers how old the bridge is. As expected the older the bridge the higher the risk factor. The score ranges from a risk score of 1 for bridges built after 1995 to a risk score of 5 for bridges built before 1935.

- **VPD (Vehicles per Day):** It reflects how intensively the structure is used and how many vehicles per day it supports. The score ranges from a risk score of 0 for pedestrian bridges to a risk score of 5 for bridges with a VPD greater than a given value, as agreed with the Asset owners; based on their size and volume being experienced on their network. For example, for Taranaki this was 375 vehicles.

- **Alternative Route:** it considers the time delays for any alternative routes. The score ranges from a risk score of 1 for a bridge with an alternative route causing a delay of less than 30 minutes to a risk score of 5 for bridges where no alternative access exists, or lifeline bridges.

- **ONRC:** it reflects the importance of the bridge under the One Network Road Classification. The score ranges from a risk score of 1 for bridges located on access (low volume) roads to a risk score of 5 for bridges located on arterial or regional roads.
